# Access Compliance Report Public Rights-of-Way (Curb Ramps)

Main Street: BOLSA\_AVE Cross Street: MONROE\_ST Location: NW

ADA ID: RPRK211005105438 Ramp Type: Type 1 - Perpendicular Diagonal Initial Pass/Fail: Fail Overall Compliance: No Severity Score: 2

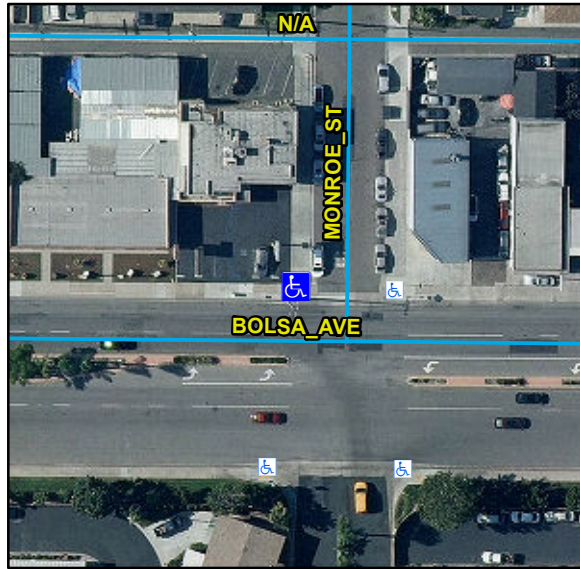
| Compliance | Description | Data | Compliance | Description | Data |
|---|---|---|---|---|---|
| No | Ramp Cross Slope (%) | 2.7 | N/A | Flare Traversable LT | N/A |

**Remove & Replace Curb Ramp With Two New Directional Ramps or Equivalent.**

**R304.5.3, STD 1115**
