# Access Compliance Report Public Rights-of-Way (Curb Ramps)

Main Street: MONROE\_ST Cross Street: BOLSA\_AVE Location: NE

ADA ID: RPRK211005105724 Ramp Type: Type 1 - Perpendicular Diagonal Initial Pass/Fail: Fail Overall Compliance: No Severity Score: 16

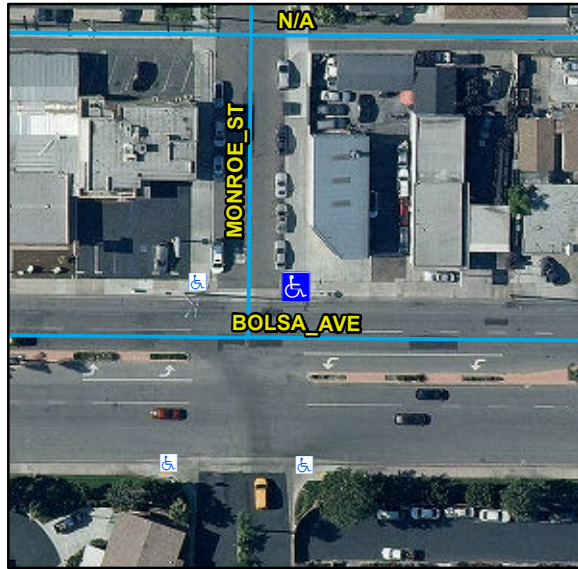
| Compliance | Description | Data | Compliance | Description | Data |
|---|---|---|---|---|---|
| No | Ramp Run Slope (%) | 11.4 | N/A | Flare Slope LT (%) | N/A |
| No | Ramp Cross Slope (%) | 2.2 | N/A | Flare Traversable LT | N/A |

**Remove & Replace Curb Ramp With Two New Directional Ramps or Equivalent.**

**R304.2.2, R304.5.3, STD 1115**
