# Access Compliance Report

## Public Rights-of-Way

### (Curb Ramps)

Main Street: BOLSA\_AVE Cross Street: N/A Location: SE

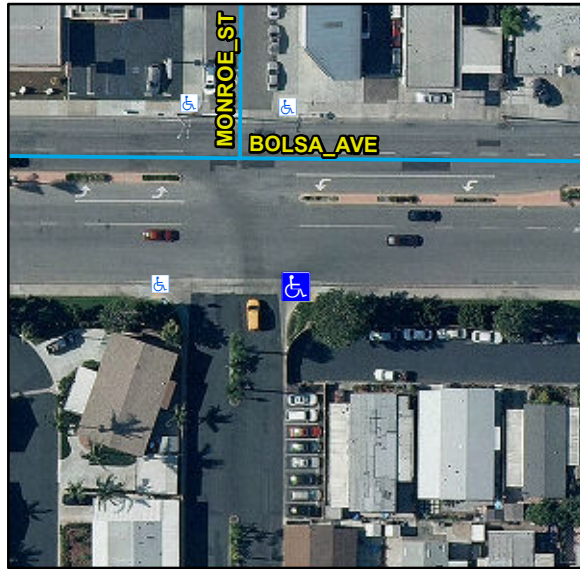
ADA ID: RPRK211005105920 Ramp Type: Type 1 - Perpendicular Diagonal Initial Pass/Fail: Pass Overall Compliance: No Severity Score: 20

R304.2.1, R304.2.2-Perp, R304.3.2-Para, R304.5.3, R305.1.4, R304.5.4, STD 1115

Remove & Replace Curb Ramp With Two New Directional Ramps or Equivalent. Remove & Replace Gutter.
