# Access Compliance Report Public Rights-of-Way (Curb Ramps)

Main Street: N/A Cross Street: BOLSA\_AVE Location: S

ADA ID: RPRK211005110251 Ramp Type: Type 1 - Perpendicular Diagonal Initial Pass/Fail: Pass Overall Compliance: No Severity Score: 20

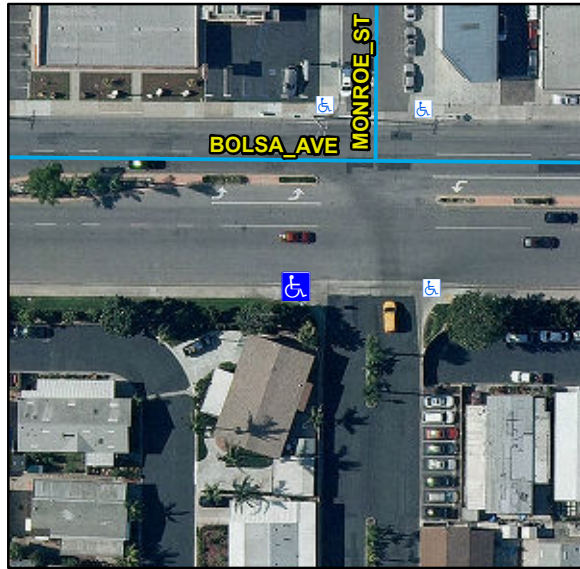
| Compliance | Description | Data | Compliance | Description | Data |
|---|---|---|---|---|---|
| N/A | Ramp Length (in) | 54 | No | Flare Type LT | |
| No | Landing Width (in) | N/A | Yes | Flare Slope RT (%) | 8.8 |
| No | Landing Run Slope (%) | N/A | N/A | Flare Traversable RT | Yes |
| No | Landing Cross Slope (%) | N/A | Yes | DWS Provided | Yes |
| N/A | Landing Shared | N/A | No | DWS Full Width | No |
| Yes | Gutter Ponding | No | No | Curb Slope | 9.6 |
| No | Gutter Run Slope (%) | 10.9 | | Road Cross Slope (%) | 5.4 |
| No | Gutter Cross Slope (%) | 5.9 | | | |

Remove & Replace Curb Ramp With Two New Directional Ramps or Equivalent. Remove & Replace Gutter.

R304.2.2, R304.2.1, R304.2.2-Perp, R304.3.2-Para, R304.5.3, R304.2.3, R305.1.4, R304.5.4, STD 1115
