# Access Compliance Report Public Rights-of-Way (Curb Ramps)

Main Street: HAZARD\_AVE Cross Street: COLONIAL\_DR Location: SE

ADA ID: RPRK211005114211 Ramp Type: Type 1 - Perpendicular Diagonal Initial Pass/Fail: Fail Overall Compliance: No Severity Score: 30

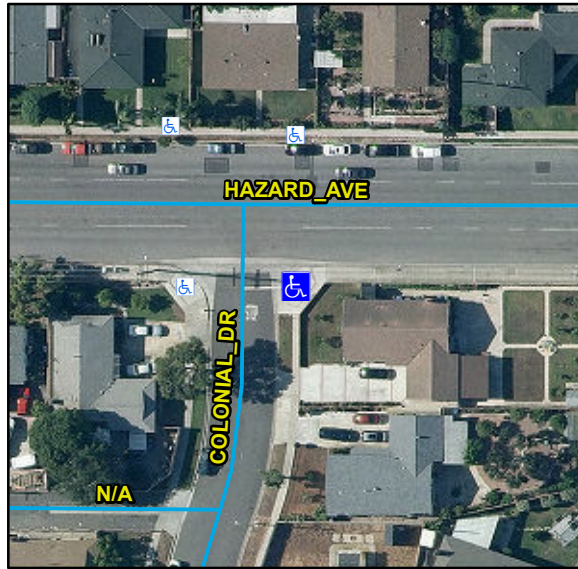
| Compliance | Description | Data | Compliance | Description | Data |
|---|---|---|---|---|---|
| No | Ramp Cross Slope (%) | 12.1 | N/A | Flare Traversable LT | N/A |

Remove & Replace Curb Ramp With Two New Directional Ramps or Equivalent.
