# Access Compliance Report Public Rights-of-Way (Curb Ramps)

Main Street: PURDY\_ST Cross Street: BIRD\_RD Location: NE

ADA ID: RPRK211005115041 Ramp Type: Type 1 - Perpendicular Diagonal Initial Pass/Fail: Fail Overall Compliance: No Severity Score: 15

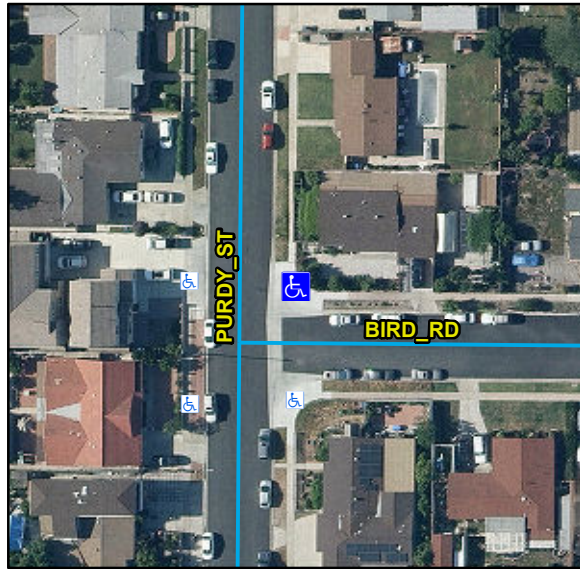
| Compliance | Description | Data | Compliance | Description | Data |
|---|---|---|---|---|---|
| No | Ramp Run Slope (%) | 10.4 | N/A | Flare Slope LT (%) | N/A |

**Remove & Replace Curb Ramp With Two New Directional Ramps or Equivalent.**

**R304.2.2, STD 1115**
