# Access Compliance Report Public Rights-of-Way (Curb Ramps)

Main Street: BIRD\_RD Cross Street: PURDY\_ST Location: SE

ADA ID: RPRK211005115225 Ramp Type: Type 1 - Perpendicular Diagonal Initial Pass/Fail: Fail Overall Compliance: No Severity Score: 15

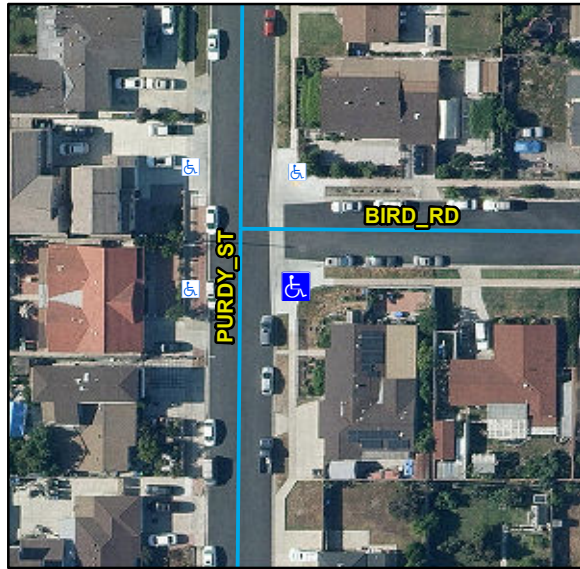
| Compliance | Description | Data | Compliance | Description | Data |
|---|---|---|---|---|---|
| No | Ramp Run Slope (%) | 11.6 | N/A | Flare Slope LT (%) | N/A |

**Remove & Replace Curb Ramp With Two New Directional Ramps or Equivalent.**

**R304.2.2, STD 1115**
