# Access Compliance Report Public Rights-of-Way (Curb Ramps)

Main Street: BIRD\_RD Cross Street: HUNTER\_LN Location: N

ADA ID: RPRK211005115534 Ramp Type: Type 1 - Perpendicular Diagonal Initial Pass/Fail: Fail Overall Compliance: No Severity Score: 16

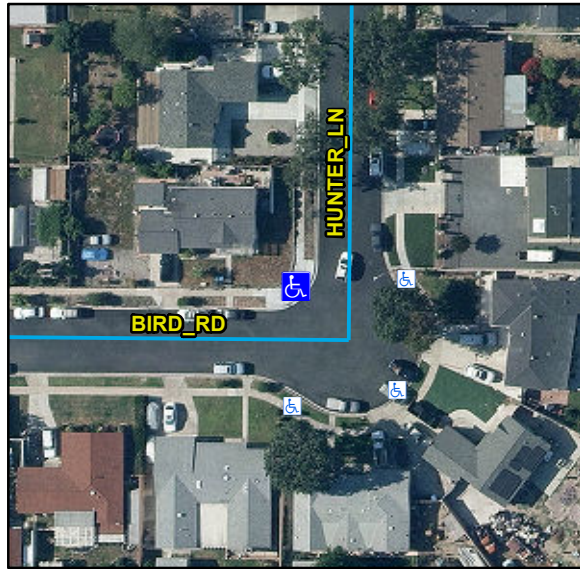
| Compliance | Description | Data | Compliance | Description | Data |
|---|---|---|---|---|---|
| No | Ramp Run Slope (%) | 10.2 | N/A | Flare Slope LT (%) | N/A |
| No | Ramp Cross Slope (%) | 2.8 | N/A | Flare Traversable LT | N/A |

Remove & Replace Curb Ramp With Two New Directional Ramps or Equivalent.

R304.2.2, R304.5.3, STD 1115
