# Access Compliance Report Public Rights-of-Way (Curb Ramps)

**Main Street:** EDEN\_ST **Cross Street:** ROOSEVELT\_AVE **Location:** SW

**ADA ID:** RPRK211005121547 **Ramp Type:**Type 1 - Perpendicular Diagonal Initial Pass/Fail: Fail **Overall Compliance:** No **Severity Score:** 15

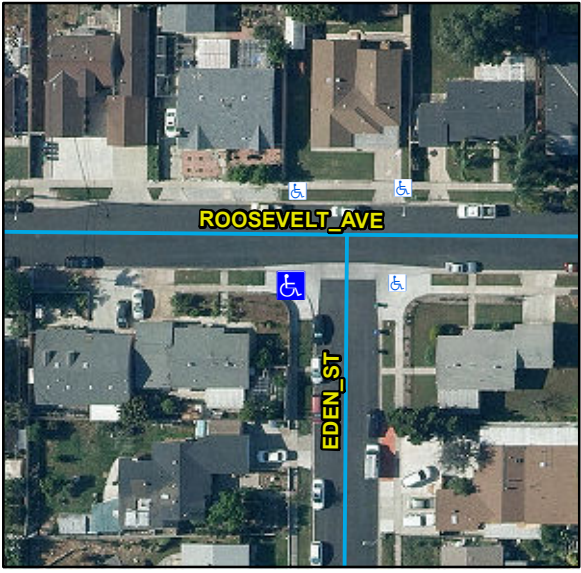
Compliance	Description	Data	Compliance	Description	Data
N/A	Ramp Length (in)	78	N/A	Flare Type LT	
Yes	Ramp Width (in)	48			N/A
No	Ramp Run Slope (%)	9.6	N/A	Flare Slope LT (%)	N/A
Yes	Ramp Cross Slope (%)	1.3	N/A	Flare Traversable LT	N/A
N/A	Landing Present	N/A	N/A	Flare Type RT	
N/A	Landing Length (in)	N/A			N/A
N/A	Landing Width (in)	N/A	N/A	Flare Slope RT (%)	N/A
N/A	Landing Run Slope (%)	N/A	N/A	Flare Traversable RT	N/A
N/A	Landing Cross Slope (%)	N/A	N/A	DWS Provided	N/A
N/A	Landing Movement Obstructed?	N/A	N/A	DWS Contrast	N/A
	Landing Movement Type	N/A	N/A	DWS Length (in)	N/A
N/A	Landing Shared	N/A	N/A	DWS Full Width	N/A
N/A	Clear Space	Yes	N/A	DWS Offset Left (in)	N/A
N/A	Clear Space To Crosswalk (in)	N/A	N/A	DWS Offset Right (in)	N/A
N/A	Marked Crosswalk 1	No	N/A	Marked Crosswalk 2	No
	Crossing 1 Direction	E		Crossing 2 Direction	N
	Marked Crosswalk 1 Width (in)	N/A		Marked Crosswalk 2 Width (in)	N/A

N/A	Ramp Inside Crosswalk 1	N/A	Yes	Ramp Inside Crosswalk 2	N/A
	Crossing 1 Slope (%)	5		Crossing 2 Slope (%)	2.7
	Crossing 1 Cross Slope (%)	2.4		Crossing 2 Cross Slope (%)	1.8
N/A	Gutter Ponding	N/A	No	Curb Slope	6.1
Yes	Gutter Lip Height (in)	0		Road Run Slope (%)	2.5
N/A	Gutter Run Slope (%)	N/A		Road Cross Slope (%)	0
N/A	Gutter Cross Slope (%)	N/A			
Yes	Overall Surface Condition:	Acceptable	Yes	Perp Joint Present	Yes
	Cross Gutter Present?	Yes		Spandrel Present?	Yes
	Replace Cross Gutter?	No		Replace Spandrel?	No

**Possible Solutions:**  
**Remove & Replace Curb Ramp With Two New Directional Ramps or Equivalent.**

**OC Std/PROW:**  
 R304.2.2, STD 1115
