# Access Compliance Report Public Rights-of-Way (Curb Ramps)

| Main Street: ROOSEVELT_AVE | | Cross Street: EDEN_ST | | Location: | SE |
| ADA ID: RPRK211005121737 | Ramp Type:Type 1 - Perpendicular Diagonal Initial Pass/Fail: Fail | | Overall Compliance: No | Severity Score: | 15 |

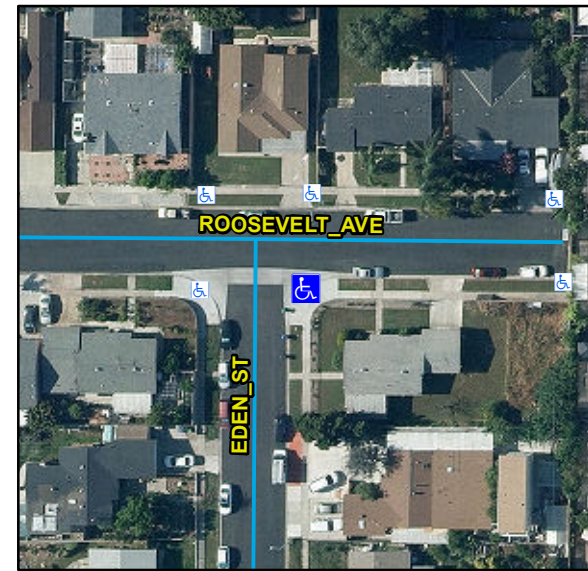
| Compliance | Description | Data | Compliance | Description | Data |
|---|---|---|---|---|---|
| No | Ramp Run Slope (%) | 11 | N/A | Flare Slope LT (%) | N/A |

**Remove & Replace Curb Ramp With Two New Directional Ramps or Equivalent.**

**R304.2.2, STD 1115**
