# Access Compliance Report Public Rights-of-Way (Curb Ramps)

| Main Street: BOLSA_AVE | | Cross Street: PURDY_ST | | Location: | W |
| ADA ID: RPRK211005133307 | Ramp Type:Type 1 - Perpendicular | Initial Pass/Fail: Fail | Overall Compliance: No | Severity Score: | 32 |

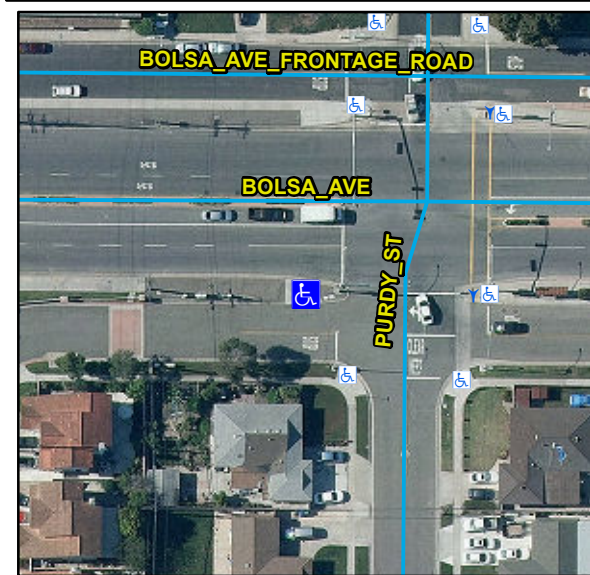
| Compliance | Description | Data | Compliance | Description | Data |
|---|---|---|---|---|---|
| No | Ramp Run Slope (%) | 12.3 | N/A | Flare Slope LT (%) | N/A |
| N/A | Gutter Ponding | N/A | No | Curb Slope | 6 |

Possible Solutions:

Remove & Replace Entire Ramp.

R304.2.2, STD 1115

Total Cost: \$ 4000
