# Access Compliance Report Public Rights-of-Way (Curb Ramps)

Main Street: BOLSA\_AVE Cross Street: PURDY\_ST Location: SE

ADA ID: RPRK211005133656 Ramp Type: Type 1 - Perpendicular Diagonal Initial Pass/Fail: Fail Overall Compliance: No Severity Score: 15

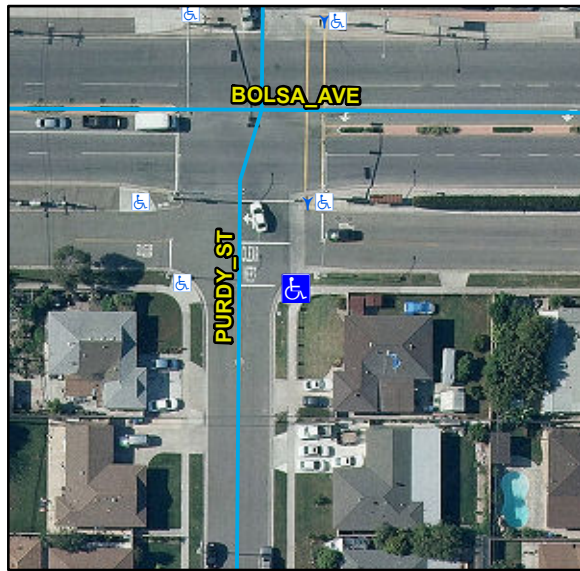
| Compliance | Description | Data | Compliance | Description | Data |
|---|---|---|---|---|---|
| No | Ramp Run Slope (%) | 9.4 | N/A | Flare Slope LT (%) | N/A |

**Remove & Replace Curb Ramp With Two New Directional Ramps or Equivalent.**

**R304.2.2, STD 1115**
