# Access Compliance Report Public Rights-of-Way (Curb Ramps)

Main Street: BOLSA\_AVE Cross Street: HUNTER\_LN Location: SE

ADA ID: RPRK211005134330 Ramp Type: Type 1 - Perpendicular Diagonal Initial Pass/Fail: Fail Overall Compliance: No Severity Score: 15

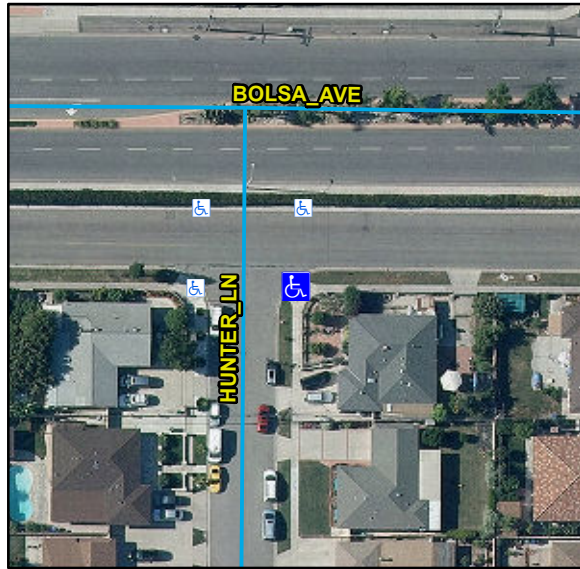
| Compliance | Description | Data | Compliance | Description | Data |
|---|---|---|---|---|---|
| No | Ramp Run Slope (%) | 10.5 | N/A | Flare Slope LT (%) | N/A |
| N/A | Gutter Ponding | N/A | No | Curb Slope | 14.6 |

Remove & Replace Curb Ramp With Two New Directional Ramps or Equivalent.

R304.2.2, STD 1115
