# Access Compliance Report Public Rights-of-Way (Curb Ramps)

Main Street: HUNTER\_LN Cross Street: ELVIRA\_AVE Location: NE

ADA ID: RPRK211005134746 Ramp Type: Type 1 - Perpendicular Diagonal Initial Pass/Fail: Fail Overall Compliance: No Severity Score: 16

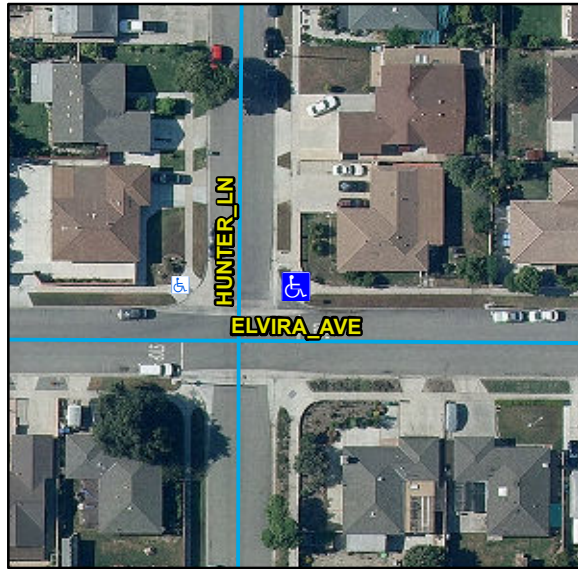
| Compliance | Description | Data | Compliance | Description | Data |
|---|---|---|---|---|---|
| No | Ramp Run Slope (%) | 9.8 | N/A | Flare Slope LT (%) | N/A |
| No | Ramp Cross Slope (%) | 3.1 | N/A | Flare Traversable LT | N/A |

Remove & Replace Curb Ramp With Two New Directional Ramps or Equivalent.

R304.2.2, R304.5.3, STD 1115
