# Access Compliance Report Public Rights-of-Way (Curb Ramps)

Main Street: ELVIRA\_AVE Cross Street: HUNTER\_LN Location: NW

ADA ID: RPRK211005135008 Ramp Type: Type 1 - Perpendicular Diagonal Initial Pass/Fail: Fail Overall Compliance: No Severity Score: 16

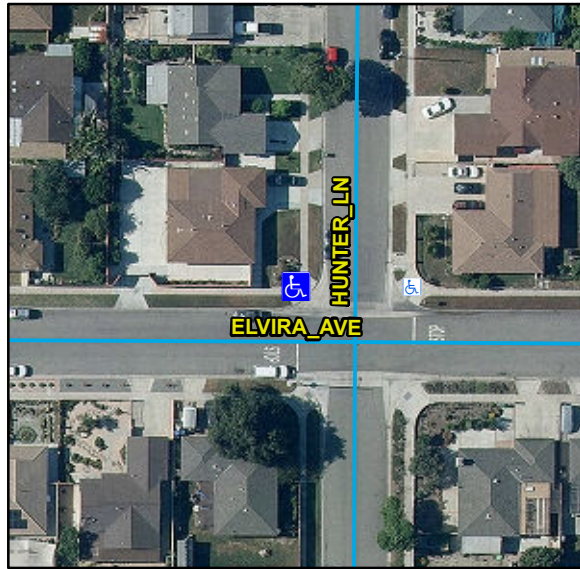
| Compliance | Description | Data | Compliance | Description | Data |
|---|---|---|---|---|---|
| No | Ramp Run Slope (%) | 10.7 | N/A | Flare Slope LT (%) | N/A |
| No | Ramp Cross Slope (%) | 2.7 | N/A | Flare Traversable LT | N/A |
| N/A | Gutter Ponding | N/A | No | Curb Slope | 11.8 |

**Remove & Replace Curb Ramp With Two New Directional Ramps or Equivalent.**

**R304.2.2, R304.5.3, STD 1115**
