# Access Compliance Report Public Rights-of-Way (Curb Ramps)

Main Street: PURDY\_ST Cross Street: ELVIRA\_AVE Location: NE

ADA ID: RPRK211005135205 Ramp Type: Type 1 - Perpendicular Diagonal Initial Pass/Fail: Fail Overall Compliance: No Severity Score: 16

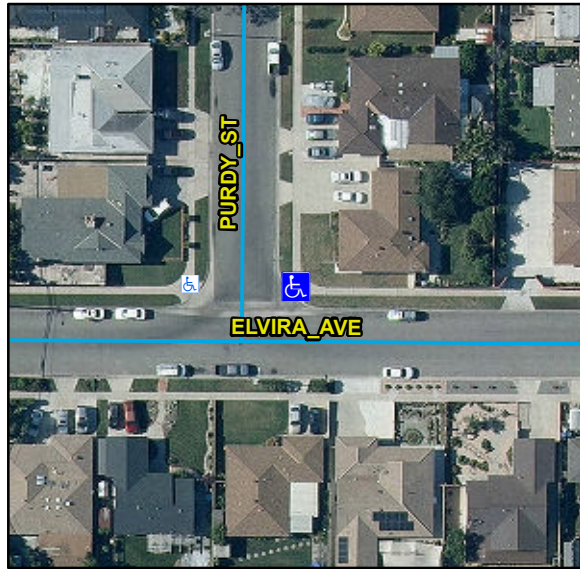
| Compliance | Description | Data | Compliance | Description | Data |
|---|---|---|---|---|---|
| No | Ramp Run Slope (%) | 11.5 | N/A | Flare Slope LT (%) | N/A |

**Remove & Replace Curb Ramp With Two New Directional Ramps or Equivalent.**

**R304.2.2, STD 1115**
