# Access Compliance Report Public Rights-of-Way (Curb Ramps)

Main Street: ELVIRA\_AVE Cross Street: PURDY\_ST Location: NW

ADA ID: RPRK211005135436 Ramp Type: Type 1 - Perpendicular Diagonal Initial Pass/Fail: Fail Overall Compliance: No Severity Score: 16

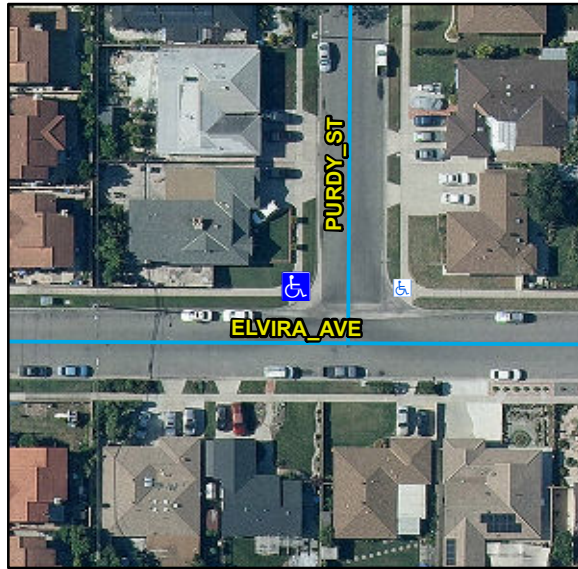
| Compliance | Description | Data | Compliance | Description | Data |
|---|---|---|---|---|---|
| No | Ramp Run Slope (%) | 11 | N/A | Flare Slope LT (%) | N/A |
| No | Ramp Cross Slope (%) | 2.8 | N/A | Flare Traversable LT | N/A |

**Remove & Replace Curb Ramp With Two New Directional Ramps or Equivalent.**
