# Access Compliance Report Public Rights-of-Way (Curb Ramps)

Main Street: **ELMORE\_WAY** Cross Street: **VAN\_BUREN\_ST** Location: **NW**

ADA ID: **RPRK211005141256** Ramp Type: **Type 1 - Perpendicular Diagonal Initial Pass/Fail: Fail** Overall Compliance: **No** Severity Score: **30**

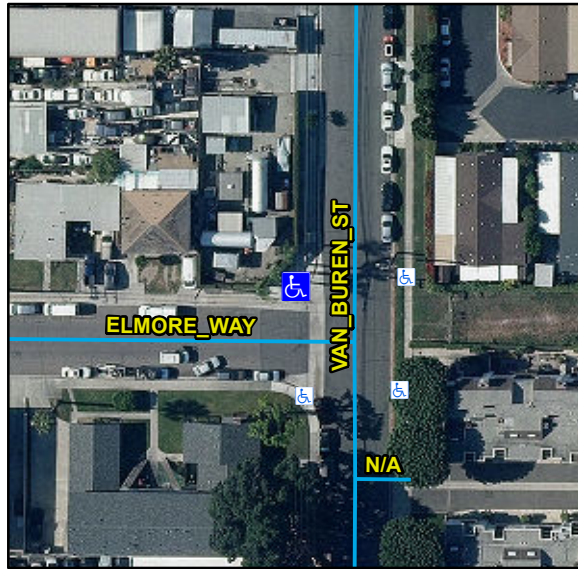
| Compliance | Description | Data | Compliance | Description | Data |
|---|---|---|---|---|---|
| <b>No</b> | Ramp Run Slope (%) | <b>12.9</b> | <b>N/A</b> | Flare Slope LT (%) | <b>N/A</b> |

**Remove & Replace Curb Ramp With Two New Directional Ramps or Equivalent.**
