# Access Compliance Report Public Rights-of-Way (Curb Ramps)

Main Street: **ELMORE WAY** Cross Street: **JACKSON ST** Location: **SE**

ADA ID: **RPRK211005141724** Ramp Type: **Type 1 - Perpendicular Diagonal** Initial Pass/Fail: **Fail** Overall Compliance: **No** Severity Score: **30**

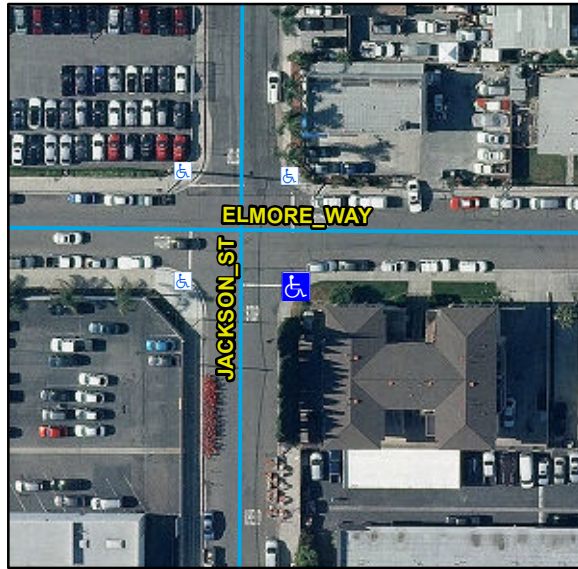
| Compliance | Description | Data | Compliance | Description | Data |
|---|---|---|---|---|---|
| <b>No</b> | Ramp Run Slope (%) | <b>14.2</b> | <b>N/A</b> | Flare Slope LT (%) | <b>N/A</b> |
| <b>No</b> | Gutter Lip Height (in) | <b>0.5</b> | | Road Run Slope (%) | <b>2.5</b> |

**Remove & Replace Curb Ramp With Two New Directional Ramps or Equivalent.**

**R304.2.2, R302.7.2, STD 1115**
