# Access Compliance Report Public Rights-of-Way (Curb Ramps)

Main Street: **ELMORE\_WAY** Cross Street: **JACKSON\_ST** Location: **NW**

ADA ID: **RPRK211005142142** Ramp Type: **Type 1 - Perpendicular Diagonal** Initial Pass/Fail: **Fail** Overall Compliance: **No** Severity Score: **32**

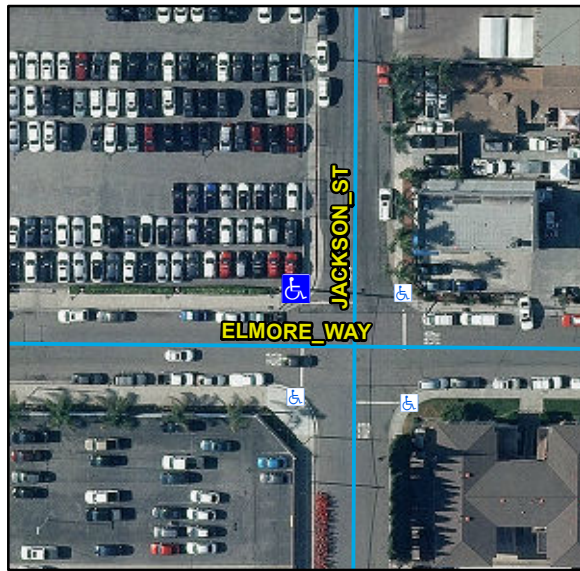
| Compliance | Description | Data | Compliance | Description | Data |
|---|---|---|---|---|---|
| <b>No</b> | Ramp Run Slope (%) | <b>13.4</b> | <b>N/A</b> | Flare Slope LT (%) | <b>N/A</b> |
| <b>No</b> | Ramp Cross Slope (%) | <b>2.8</b> | <b>N/A</b> | Flare Traversable LT | <b>N/A</b> |
| <b>No</b> | Gutter Lip Height (in) | <b>0.5</b> | | Road Run Slope (%) | <b>3.1</b> |

**Remove & Replace Curb Ramp With Two New Directional Ramps or Equivalent. Grind Gutter Lip.**

**R304.2.2, R304.5.3, R302.7.2, STD 1115**
