# Access Compliance Report Public Rights-of-Way (Curb Ramps)

Main Street: JACKSON\_ST Cross Street: ELMORE\_WAY Location: SW

ADA ID: RPRK211005142345 Ramp Type: Type 1 - Perpendicular Diagonal Initial Pass/Fail: Fail Overall Compliance: No Severity Score: 16

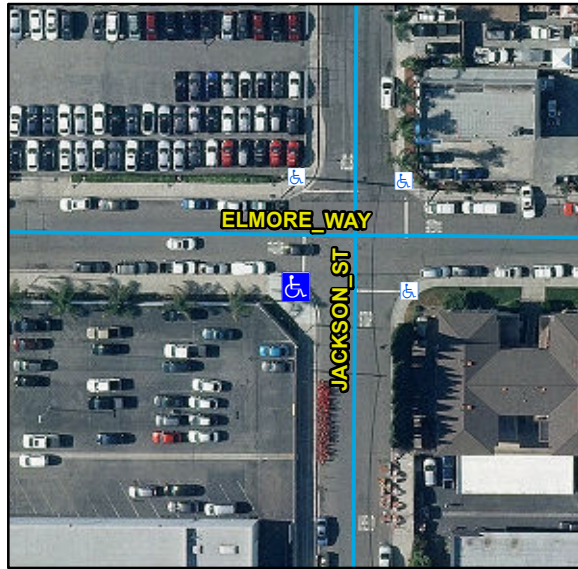
| Compliance | Description | Data | Compliance | Description | Data |
|---|---|---|---|---|---|
| No | Ramp Run Slope (%) | 8.5 | N/A | Flare Slope LT (%) | N/A |
| No | Ramp Cross Slope (%) | 3.1 | N/A | Flare Traversable LT | N/A |

**Remove & Replace Curb Ramp With Two New Directional Ramps or Equivalent.**

**R304.2.2, R304.5.3, STD 1115**
