# Access Compliance Report Public Rights-of-Way (Curb Ramps)

Main Street: **ELMORE\_WAY** Cross Street: **BEACH\_BLV** Location: **SE**

ADA ID: **RPRK211005142803** Ramp Type: **Type 1 - Perpendicular Diagonal Initial Pass/Fail: Fail** Overall Compliance: **No** Severity Score: **30**

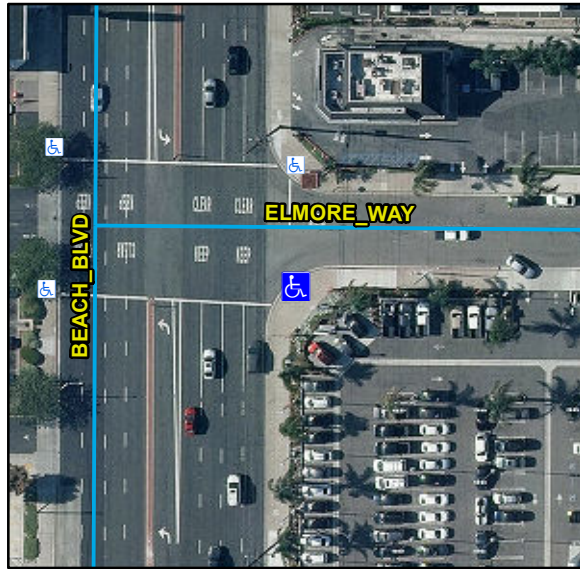
| Compliance | Description | Data | Compliance | Description | Data |
|---|---|---|---|---|---|
| <b>No</b> | Ramp Run Slope (%) | <b>14.7</b> | <b>N/A</b> | Flare Slope LT (%) | <b>N/A</b> |
| <b>N/A</b> | Gutter Ponding | <b>N/A</b> | <b>No</b> | Curb Slope | <b>11.5</b> |

**Remove & Replace Curb Ramp With Two New Directional Ramps or Equivalent.**

**R304.2.2, STD 1115**
