# Access Compliance Report Public Rights-of-Way (Curb Ramps)

Main Street: BEACH\_BLVD Cross Street: MCFADDEN\_AVE Location: NE

ADA ID: RPRK211005144226 Ramp Type: Type 1 - Perpendicular Diagonal Initial Pass/Fail: Fail Overall Compliance: No Severity Score: 15

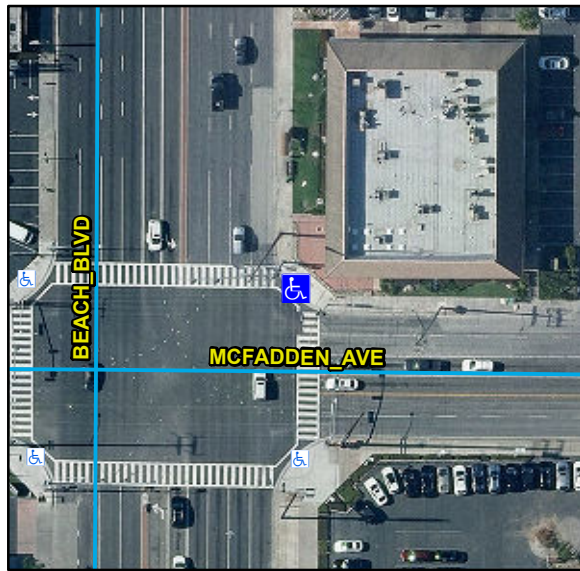
| Compliance | Description | Data | Compliance | Description | Data |
|---|---|---|---|---|---|
| No | Ramp Run Slope (%) | 8.6 | N/A | Flare Slope LT (%) | N/A |

Remove & Replace Curb Ramp With Two New Directional Ramps or Equivalent. Restripe Crosswalk.

R304.2.2, STD 1115
