# Access Compliance Report Public Rights-of-Way (Curb Ramps)

Main Street: MCFADDEN\_AVE Cross Street: BEACH\_BLVD Location: NW

ADA ID: RPRK211005144857 Ramp Type: Type 1 - Perpendicular Diagonal Initial Pass/Fail: Fail Overall Compliance: No Severity Score: 16

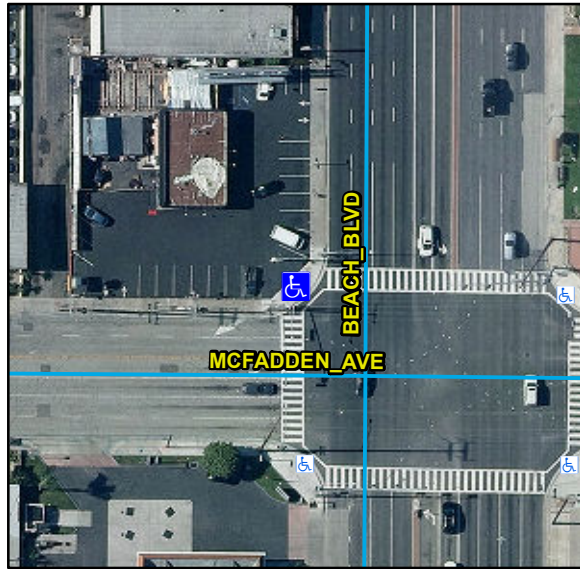
| Compliance | Description | Data | Compliance | Description | Data |
|---|---|---|---|---|---|
| No | Ramp Run Slope (%) | 9.5 | N/A | Flare Slope LT (%) | N/A |
| No | Ramp Cross Slope (%) | 4.9 | N/A | Flare Traversable LT | N/A |

Remove & Replace Curb Ramp With Two New Directional Ramps or Equivalent. Restripe Crosswalk.

R304.2.2, R304.5.3, STD 1115
