# Access Compliance Report Public Rights-of-Way (Curb Ramps)

Main Street: BEACH\_BLVD Cross Street: MCFADDEN\_AVE Location: SW

ADA ID: RPRK211005145439 Ramp Type: Type 1 - Perpendicular Diagonal Initial Pass/Fail: Fail Overall Compliance: No Severity Score: 15

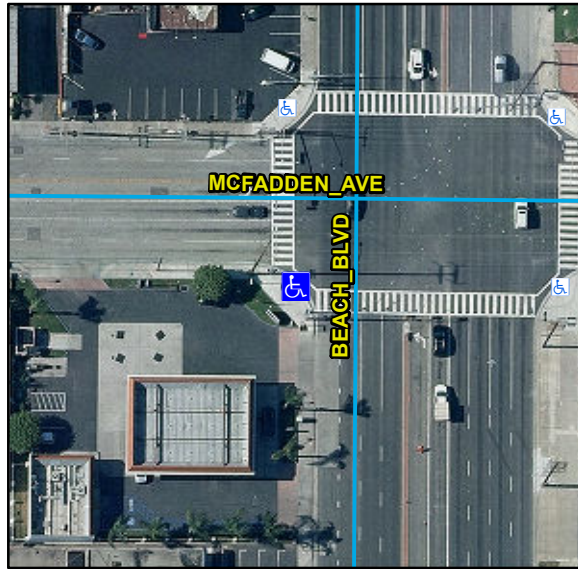
| Compliance | Description | Data | Compliance | Description | Data |
|---|---|---|---|---|---|
| No | Ramp Cross Slope (%) | 6.5 | N/A | Flare Traversable LT | N/A |

Remove & Replace Curb Ramp With Two New Directional Ramps or Equivalent. Restripe Crosswalk.

R304.2.2, R304.5.3, STD 1115
