# Access Compliance Report Public Rights-of-Way (Curb Ramps)

| Main Street: MCFADDEN_AVE | | Cross Street: BEACH_BLVD | | Location: | SE |
| ADA ID: RPRK211005150221 | Ramp Type:Type 1 - Perpendicular Diagonal Initial Pass/Fail: Fail | | Overall Compliance: No | Severity Score: | 16 |

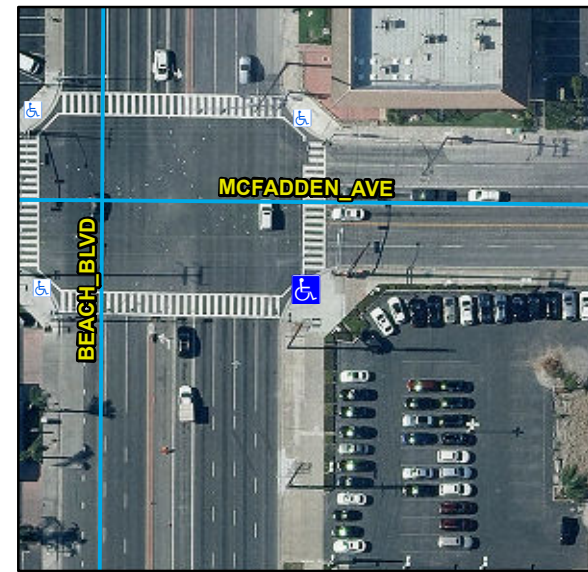
| Compliance | Description | Data | Compliance | Description | Data |
|---|---|---|---|---|---|
| No | Ramp Run Slope (%) | 11.5 | N/A | Flare Slope LT (%) | N/A |
| No | Ramp Cross Slope (%) | 2.7 | N/A | Flare Traversable LT | N/A |

**Remove & Replace Curb Ramp With Two New Directional Ramps or Equivalent. Restripe Crosswalk.**

**R304.2.2, R304.5.3, STD 1115**

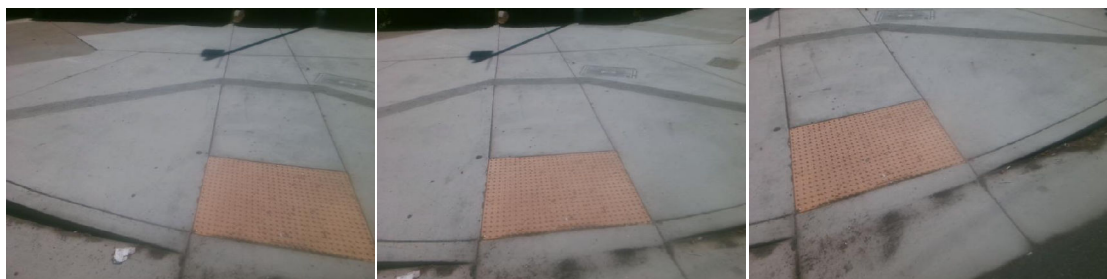
| Compliance | Description | Data | Compliance | Description | Data |
|---|---|---|---|---|---|
| N/A | Ramp Length (in) | 106 | N/A | Flare Type LT | |
| Yes | Ramp Width (in) | 48 | | | N/A |
