# Access Compliance Report Public Rights-of-Way (Curb Ramps)

Main Street: MCFADDEN\_AVE Cross Street: JACKSON\_ST Location: NW

ADA ID: RPRK211005150809 Ramp Type: Type 1 - Perpendicular Diagonal Initial Pass/Fail: Pass Overall Compliance: No Severity Score: 10

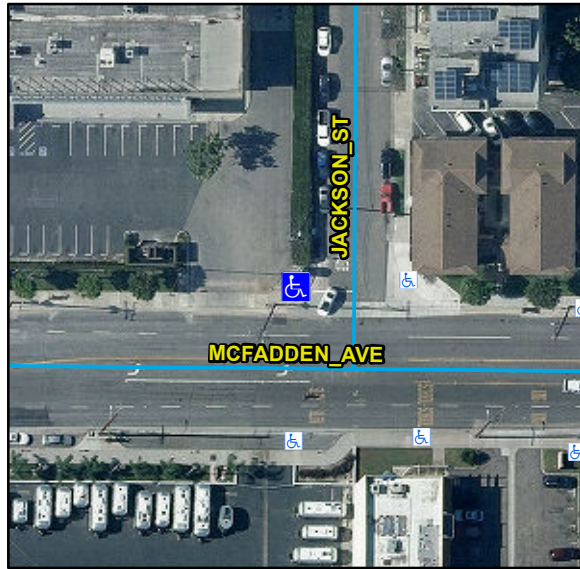
| Compliance | Description | Data | Compliance | Description | Data |
|---|---|---|---|---|---|
| Yes | Ramp Run Slope (%) | 6.1 | No | Flare Slope LT (%) | 12.8 |
| No | Landing Run Slope (%) | 2.4 | N/A | Flare Traversable RT | No |
| No | Landing Cross Slope (%) | 2.9 | Yes | DWS Provided | Yes |
| No | Gutter Run Slope (%) | 6.8 | | Road Cross Slope (%) | 1.7 |

**Remove & Replace Curb Ramp With Two New Directional Ramps or Equivalent. Remove & Replace Gutter.**

**R304.2.1, R304.2.2-Perp, R304.3.2-Para, R304.5.3, R304.2.3, R304.5.4, STD 1115**
