# Access Compliance Report Public Rights-of-Way (Curb Ramps)

Main Street: JACKSON\_ST Cross Street: MCFADDEN\_AVE Location: NE

ADA ID: RPRK211005151149 Ramp Type: Type 1 - Perpendicular Diagonal Initial Pass/Fail: Fail Overall Compliance: No Severity Score: 15

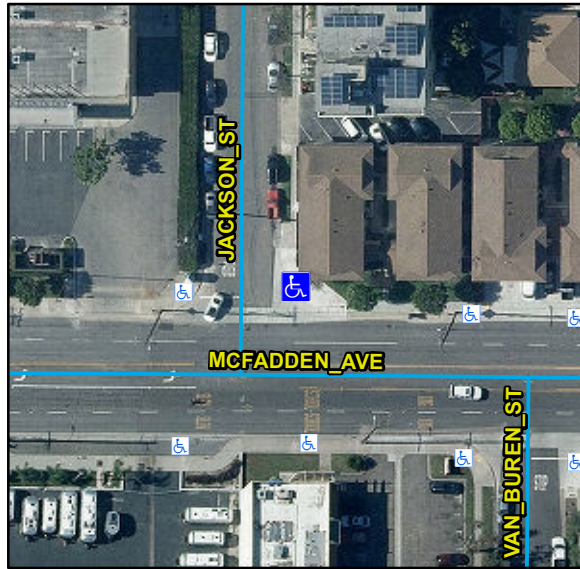
| Compliance | Description | Data | Compliance | Description | Data |
|---|---|---|---|---|---|
| No | Ramp Run Slope (%) | 11.4 | N/A | Flare Slope LT (%) | N/A |

**Remove & Replace Curb Ramp With Two New Directional Ramps or Equivalent.**

**R304.2.2, STD 1115**
