# Access Compliance Report Public Rights-of-Way (Curb Ramps)

Main Street: BOLSA\_AVE Cross Street: PACIFIC\_ST Location: SE

ADA ID: RPRK211005165245 Ramp Type: Type 1 - Perpendicular Diagonal Initial Pass/Fail: Fail Overall Compliance: No Severity Score: 16

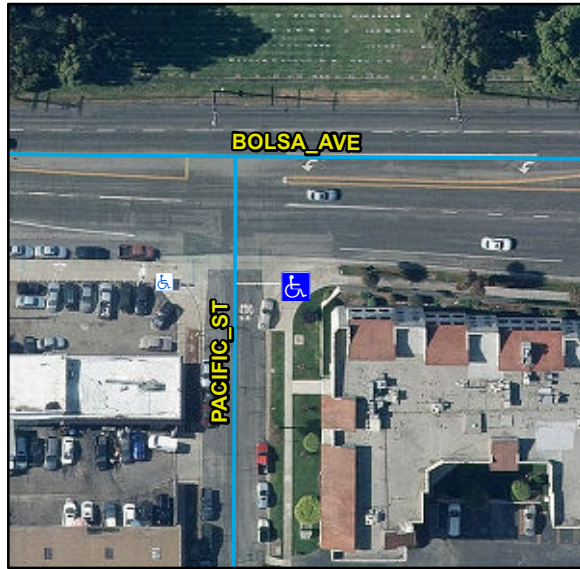
| Compliance | Description | Data | Compliance | Description | Data |
|---|---|---|---|---|---|
| No | Ramp Run Slope (%) | 10.5 | N/A | Flare Slope LT (%) | N/A |
| No | Ramp Cross Slope (%) | 2.8 | N/A | Flare Traversable LT | N/A |

Remove & Replace Curb Ramp With Two New Directional Ramps or Equivalent.
