# Access Compliance Report Public Rights-of-Way (Curb Ramps)

Main Street: PACIFIC\_ST Cross Street: BOLSA\_AVE Location: SW

ADA ID: RPRK211005165445 Ramp Type: Type 1 - Perpendicular Diagonal Initial Pass/Fail: Fail Overall Compliance: No Severity Score: 15

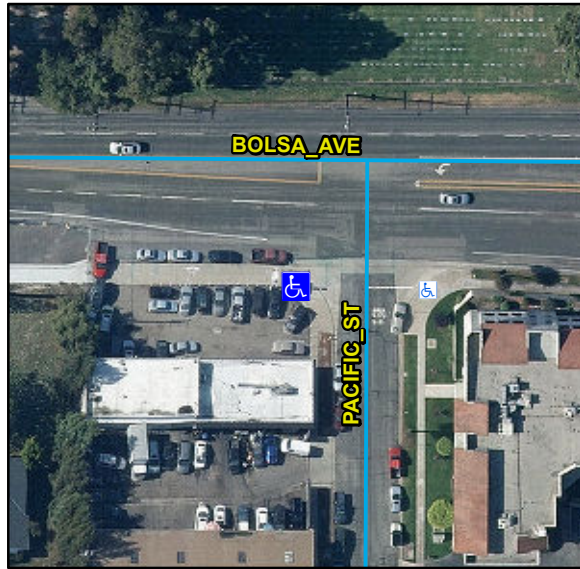
| Compliance | Description | Data | Compliance | Description | Data |
|---|---|---|---|---|---|
| No | Ramp Run Slope (%) | 11.5 | N/A | Flare Slope LT (%) | N/A |

Remove & Replace Curb Ramp With Two New Directional Ramps or Equivalent.

R304.2.2, STD 1115
