# Access Compliance Report Public Rights-of-Way (Curb Ramps)

Main Street: PINE\_ST Cross Street: BEACH\_BLVD Location: SE

ADA ID: RPRK211005170529 Ramp Type: Type 1 - Perpendicular Diagonal Initial Pass/Fail: Fail Overall Compliance: No Severity Score: 30

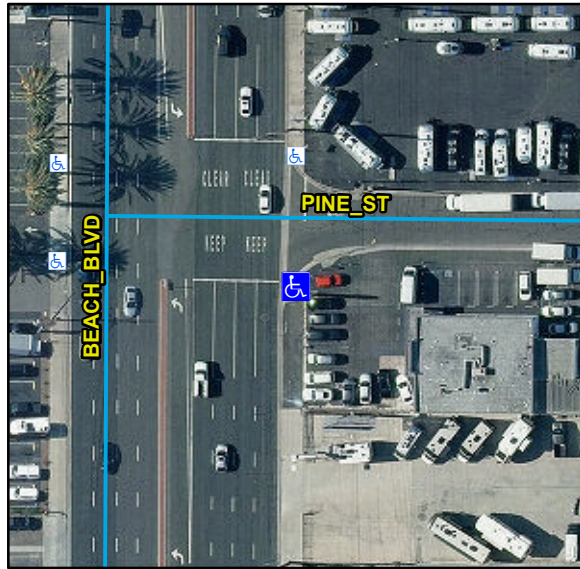
| Compliance | Description | Data | Compliance | Description | Data |
|---|---|---|---|---|---|
| No | Ramp Run Slope (%) | 16.9 | N/A | Flare Slope LT (%) | N/A |
| No | Gutter Lip Height (in) | 0.25 | | Road Run Slope (%) | 4.6 |

Remove & Replace Curb Ramp With Two New Directional Ramps or Equivalent.

R304.2.2, R302.7.2, STD 1115
