# Access Compliance Report Public Rights-of-Way (Curb Ramps)

Main Street: PINE\_ST Cross Street: BEACH\_BLVD Location: N

ADA ID: RPRK211005170728 Ramp Type: Type 7 - Directional 2 Initial Pass/Fail: Fail Overall Compliance: No Severity Score: 45

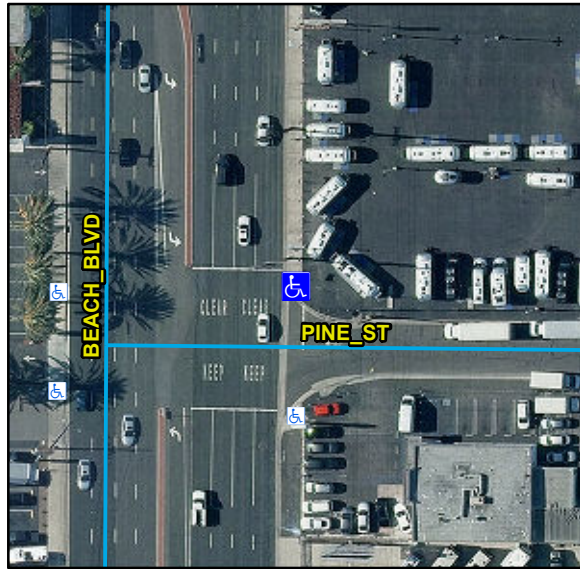
| Compliance | Description | Data | Compliance | Description | Data |
|---|---|---|---|---|---|
| No | Ramp Cross Slope (%) | 7.1 | N/A | Flare Traversable LT | N/A |
| No | Gutter Lip Height (in) | 0.25 | | Road Run Slope (%) | N/A |

Remove & Replace Entire Ramp. Grind Gutter Lip.

R304.5.3, R302.7.2, STD 1115
