# Access Compliance Report Public Rights-of-Way (Curb Ramps)

Main Street: ROCKWELL\_AVE Cross Street: BEACH\_BLVD Location: NW

ADA ID: RPRK211005171435 Ramp Type: Type 1 - Perpendicular Diagonal Initial Pass/Fail: Fail Overall Compliance: No Severity Score: 16

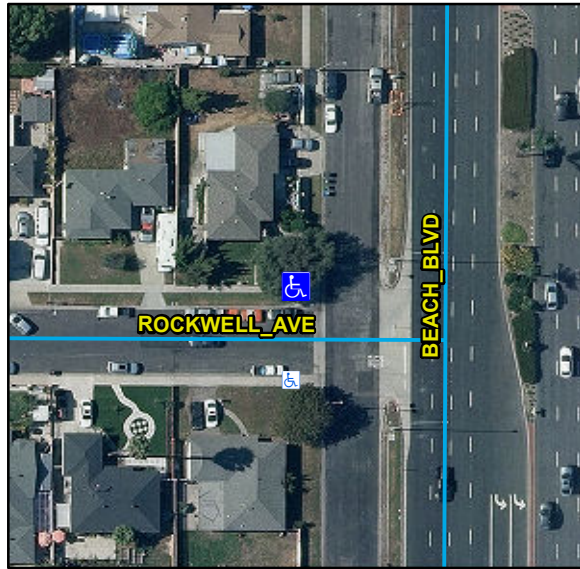
| Compliance | Description | Data | Compliance | Description | Data |
|---|---|---|---|---|---|
| No | Ramp Run Slope (%) | 11.8 | N/A | Flare Slope LT (%) | N/A |
| No | Ramp Cross Slope (%) | 3.5 | N/A | Flare Traversable LT | N/A |
| No | Gutter Lip Height (in) | 0.25 | | Road Run Slope (%) | 1.2 |

Remove & Replace Curb Ramp With Two New Directional Ramps or Equivalent.
