# Access Compliance Report Public Rights-of-Way (Curb Ramps)

Main Street: BEACH\_BLVD Cross Street: ROCKWELL\_AVE Location: SW

ADA ID: RPRK211005171638 Ramp Type: Type 7 - Directional 2 Initial Pass/Fail: Fail Overall Compliance: No Severity Score: 32

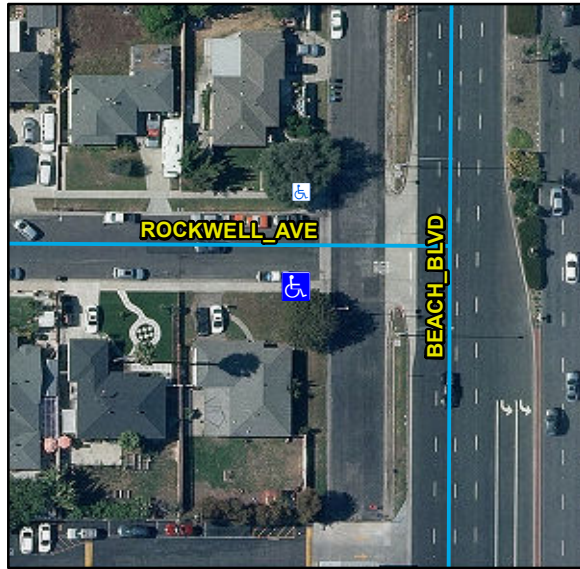
| Compliance | Description | Data | Compliance | Description | Data |
|---|---|---|---|---|---|
| No | Ramp Run Slope (%) | 17.1 | N/A | Flare Slope LT (%) | N/A |
| No | Ramp Cross Slope (%) | 2.4 | N/A | Flare Traversable LT | N/A |

Remove & Replace Entire Ramp.
