# Access Compliance Report Public Rights-of-Way (Curb Ramps)

Main Street: PACIFIC\_ST Cross Street: ROCKWELL\_AVE Location: NE

ADA ID: RPRK211005172407 Ramp Type: Type 1 - Perpendicular Diagonal Initial Pass/Fail: Fail Overall Compliance: No Severity Score: 15

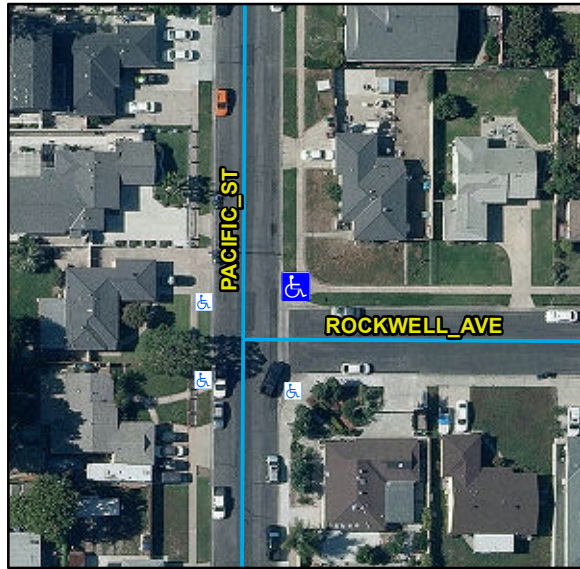
| Compliance | Description | Data | Compliance | Description | Data |
|---|---|---|---|---|---|
| No | Ramp Run Slope (%) | 11.3 | N/A | Flare Slope LT (%) | N/A |

**Remove & Replace Curb Ramp With Two New Directional Ramps or Equivalent.**

**R304.2.2, STD 1115**
