# Access Compliance Report Public Rights-of-Way (Curb Ramps)

Main Street: LEDON\_WAY Cross Street: PACIFIC\_ST Location: SE

ADA ID: RPRK211005172618 Ramp Type: Type 1 - Perpendicular Diagonal Initial Pass/Fail: Fail Overall Compliance: No Severity Score: 15

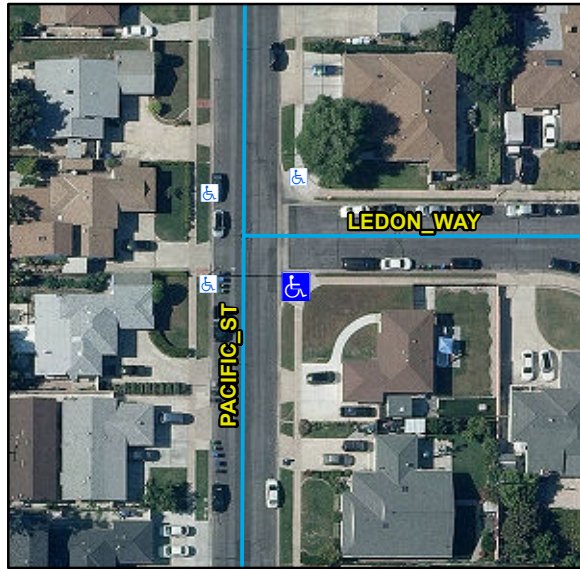
| Compliance | Description | Data | Compliance | Description | Data |
|---|---|---|---|---|---|
| No | Ramp Run Slope (%) | 10.9 | N/A | Flare Slope LT (%) | N/A |
| N/A | Gutter Ponding | N/A | No | Curb Slope | 14.7 |

Remove & Replace Curb Ramp With Two New Directional Ramps or Equivalent.

R304.2.2, STD 1115
