# Access Compliance Report Public Rights-of-Way (Curb Ramps)

Main Street: PACIFIC\_ST Cross Street: LEDON\_WAY Location: NE

ADA ID: RPRK211005172947 Ramp Type: Type 1 - Perpendicular Diagonal Initial Pass/Fail: Fail Overall Compliance: No Severity Score: 30

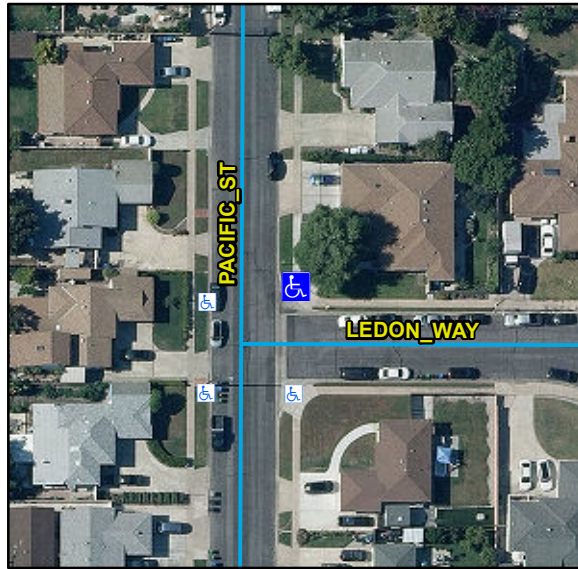
| Compliance | Description | Data | Compliance | Description | Data |
|---|---|---|---|---|---|
| No | Ramp Run Slope (%) | 12.4 | N/A | Flare Slope LT (%) | N/A |

Remove & Replace Curb Ramp With Two New Directional Ramps or Equivalent.

R304.2.2, STD 1115
