# Access Compliance Report Public Rights-of-Way (Curb Ramps)

Main Street: PACIFIC\_ST Cross Street: HARHAY\_AVE Location: S

ADA ID: RPRK211005173513 Ramp Type: Type 1 - Perpendicular Diagonal Initial Pass/Fail: Fail Overall Compliance: No Severity Score: 30

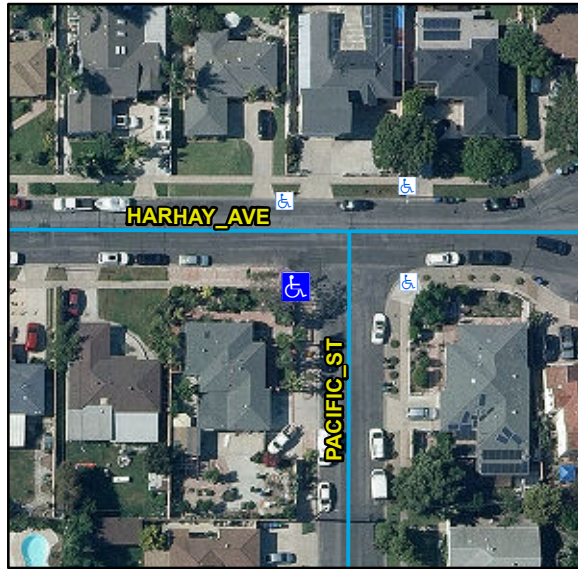
| Compliance | Description | Data | Compliance | Description | Data |
|---|---|---|---|---|---|
| No | Ramp Run Slope (%) | 12.3 | N/A | Flare Slope LT (%) | N/A |

Remove & Replace Curb Ramp With Two New Directional Ramps or Equivalent.

R304.2.2, STD 1115
