# Access Compliance Report Public Rights-of-Way (Curb Ramps)

Main Street: HARHAY\_AVE Cross Street: CEDARWOOD\_AVE Location: SE

ADA ID: RPRK211005173751 Ramp Type: Type 1 - Perpendicular Diagonal Initial Pass/Fail: Fail Overall Compliance: No Severity Score: 30

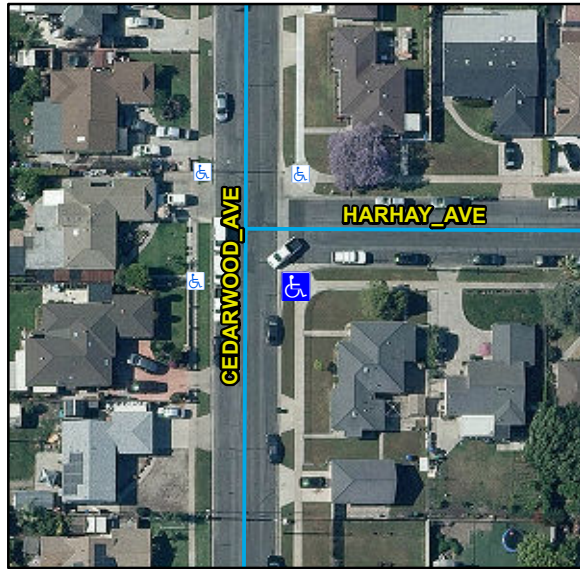
| Compliance | Description | Data | Compliance | Description | Data |
|---|---|---|---|---|---|
| No | Ramp Run Slope (%) | 14.3 | N/A | Flare Slope LT (%) | N/A |

Remove & Replace Curb Ramp With Two New Directional Ramps or Equivalent.

R304.2.2, STD 1115
