# Access Compliance Report Public Rights-of-Way (Curb Ramps)

Main Street: CEDARWOOD\_AVE Cross Street: ROCKWELL\_AVE Location: NE

ADA ID: RPRK211005175040 Ramp Type: Type 1 - Perpendicular Diagonal Initial Pass/Fail: Fail Overall Compliance: No Severity Score: 15

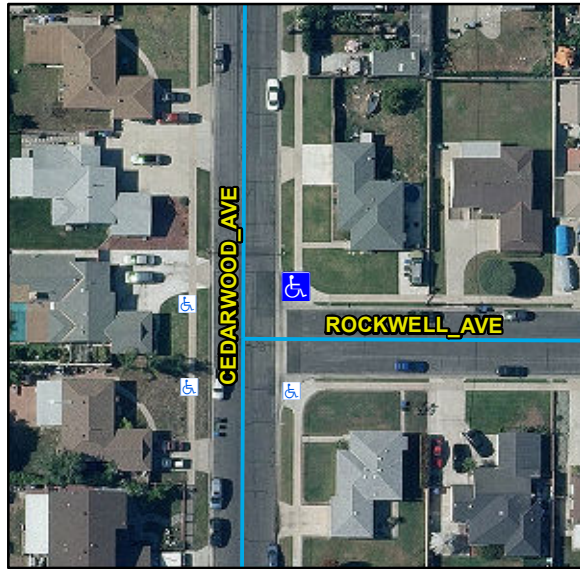
| Compliance | Description | Data | Compliance | Description | Data |
|---|---|---|---|---|---|
| No | Ramp Run Slope (%) | 8.5 | N/A | Flare Slope LT (%) | N/A |

Remove & Replace Curb Ramp With Two New Directional Ramps or Equivalent.

R304.2.2, STD 1115
