# Access Compliance Report

## Public Rights-of-Way

### (Curb Ramps)

Main Street: **DARWIN\_AVE** Cross Street: **CEDARWOOD\_AVE** Location: **SE**

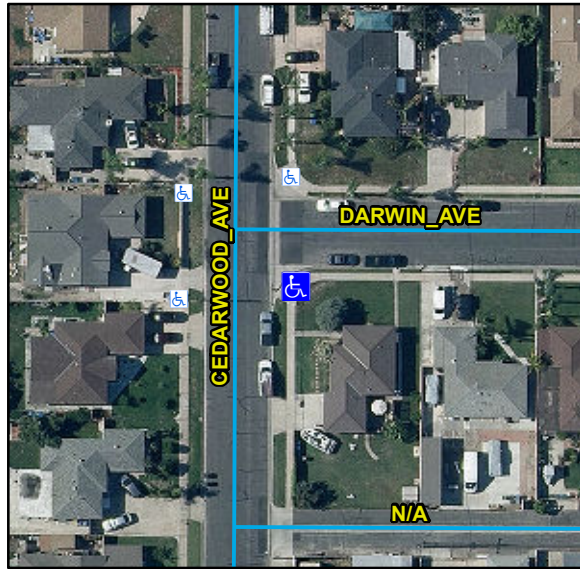
ADA ID: **RPRK211005180102** Ramp Type: **Type 1 - Perpendicular Diagonal** Initial Pass/Fail: **Fail** Overall Compliance: **No** Severity Score: **15**

| Compliance | Description | Data | Compliance | Description | Data |
|---|---|---|---|---|---|
| <b>No</b> | Ramp Run Slope (%) | <b>11.1</b> | <b>N/A</b> | Flare Slope LT (%) | <b>N/A</b> |
| <b>N/A</b> | Gutter Ponding | <b>N/A</b> | <b>No</b> | Curb Slope | <b>15.7</b> |

**Remove & Replace Curb Ramp With Two New Directional Ramps or Equivalent.**

**R304.2.2, STD 1115**

Total Cost: \$ **6160**
