Access Compliance Report Public Rights-of-Way (Curb Ramps)

Main Street: **SUGAR_AVE** Cross Street: **CEDARWOOD_AVE** Location: **NW**

ADA ID: **RPRK211005180442** Ramp Type: **Type 1 - Perpendicular Diagonal** Initial Pass/Fail: **Fail** Overall Compliance: **No** Severity Score: **16**

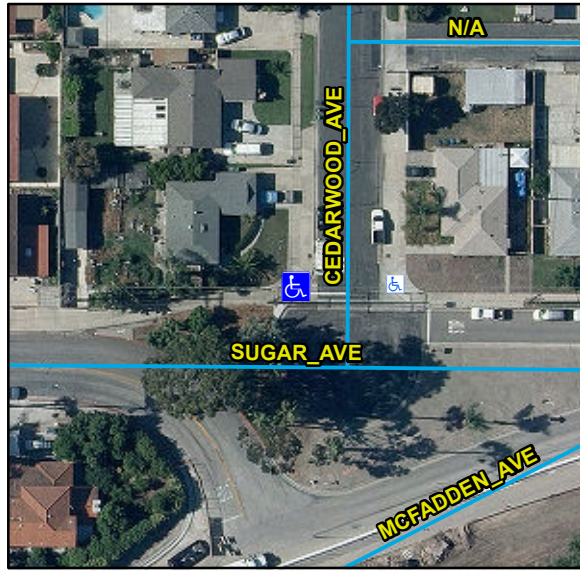
Compliance	Description	Data	Compliance	Description	Data
N/A	Ramp Length (in)	104	N/A	Flare Type LT	
Yes	Ramp Width (in)	48			N/A
No	Ramp Run Slope (%)	11.9	N/A	Flare Slope LT (%)	N/A
Yes	Ramp Cross Slope (%)	1.2	N/A	Flare Traversable LT	N/A
N/A	Landing Present	N/A	N/A	Flare Type RT	
N/A	Landing Length (in)	N/A			N/A
N/A	Landing Width (in)	N/A	N/A	Flare Slope RT (%)	N/A
N/A	Landing Run Slope (%)	N/A	N/A	Flare Traversable RT	N/A
N/A	Landing Cross Slope (%)	N/A	N/A	DWS Provided	N/A
N/A	Landing Movement Obstructed?	N/A	N/A	DWS Contrast	N/A
	Landing Movement Type	N/A	N/A	DWS Length (in)	N/A
N/A	Landing Shared	N/A	N/A	DWS Full Width	N/A
N/A	Clear Space	Yes	N/A	DWS Offset Left (in)	N/A
N/A	Clear Space To Crosswalk (in)	N/A	N/A	DWS Offset Right (in)	N/A
N/A	Marked Crosswalk 1	No	N/A	Marked Crosswalk 2	No
	Crossing 1 Direction	S		Crossing 2 Direction	E
	Marked Crosswalk 1 Width (in)	N/A		Marked Crosswalk 2 Width (in)	N/A

N/A	Ramp Inside Crosswalk 1	N/A	Yes	Ramp Inside Crosswalk 2	N/A
	Crossing 1 Slope (%)	5		Crossing 2 Slope (%)	1.5
	Crossing 1 Cross Slope (%)	5.1		Crossing 2 Cross Slope (%)	1.2
N/A	Gutter Ponding	N/A	No	Curb Slope	7.3
Yes	Gutter Lip Height (in)	0		Road Run Slope (%)	1.2
N/A	Gutter Run Slope (%)	N/A		Road Cross Slope (%)	4.9
N/A	Gutter Cross Slope (%)	N/A			
Yes	Overall Surface Condition: Acceptable		Yes	Perp Joint Present	Yes
	Cross Gutter Present?	Yes		Spandrel Present?	Yes
	Replace Cross Gutter?	No		Replace Spandrel?	No

Remove & Replace Curb Ramp With Two New Directional Ramps or Equivalent.
