# Access Compliance Report Public Rights-of-Way (Curb Ramps)

| Main Street: CEDARWOOD_AVE | | Cross Street: SUGAR_AVE | | Location: | NE |
| ADA ID: RPRK211005180759 | Ramp Type:Type 1 - Perpendicular Diagonal Initial Pass/Fail: Fail | | Overall Compliance: No | Severity Score: | 32 |

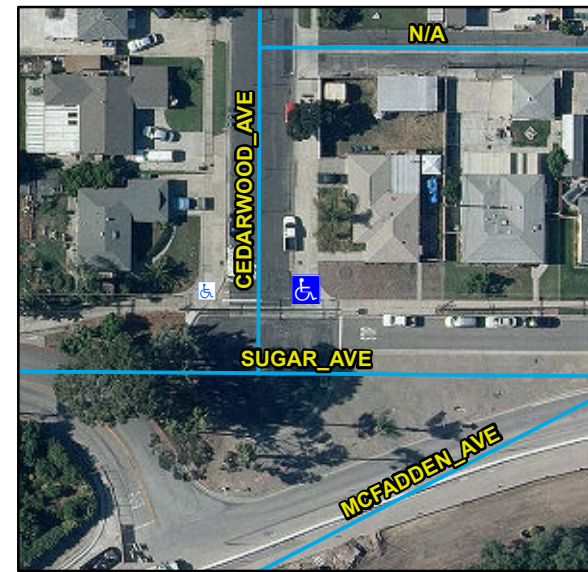
| Compliance | Description | Data | Compliance | Description | Data |
|---|---|---|---|---|---|
| No | Ramp Run Slope (%) | 13.5 | N/A | Flare Slope LT (%) | N/A |
| No | Ramp Cross Slope (%) | 2.1 | N/A | Flare Traversable LT | N/A |

Possible Solutions:

**Remove & Replace Curb Ramp With Two New Directional Ramps or Equivalent.**

R304.2.2, R304.5.3, STD 1115

Total Cost: \$ 6160
