# Access Compliance Report Public Rights-of-Way (Curb Ramps)

Main Street: MCFADDEN\_AVE Cross Street: PACIFIC\_ST Location: NW

ADA ID: RPRK211005181541 Ramp Type: Type 1 - Perpendicular Diagonal Initial Pass/Fail: Fail Overall Compliance: No Severity Score: 32

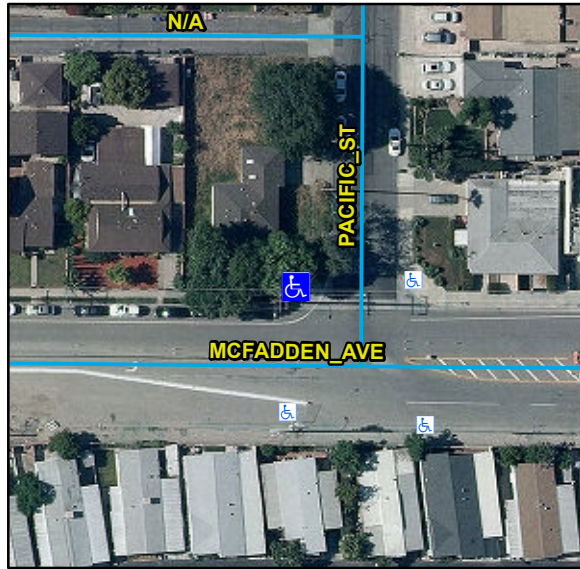
| Compliance | Description | Data | Compliance | Description | Data |
|---|---|---|---|---|---|
| No | Ramp Run Slope (%) | 12.9 | N/A | Flare Slope LT (%) | N/A |
| No | Ramp Cross Slope (%) | 2.3 | N/A | Flare Traversable LT | N/A |
| No | Gutter Lip Height (in) | 0.25 | | Road Run Slope (%) | 1.3 |

**Remove & Replace Curb Ramp With Two New Directional Ramps or Equivalent.**

**R304.2.2, R304.5.3, R302.7.2, STD 1115**
