# Access Compliance Report Public Rights-of-Way (Curb Ramps)

Main Street: PACIFIC\_ST Cross Street: MCFADDEN\_AVE Location: NE

ADA ID: RPRK211005181721 Ramp Type: Type 1 - Perpendicular Diagonal Initial Pass/Fail: Fail Overall Compliance: No Severity Score: 30

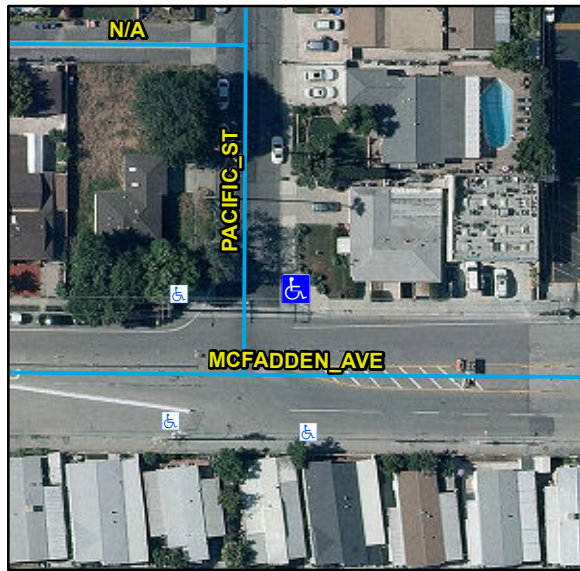
| Compliance | Description | Data | Compliance | Description | Data |
|---|---|---|---|---|---|
| No | Ramp Run Slope (%) | 12.2 | N/A | Flare Slope LT (%) | N/A |

Remove & Replace Curb Ramp With Two New Directional Ramps or Equivalent.

R304.2.2, STD 1115
