# Access Compliance Report Public Rights-of-Way (Curb Ramps)

Main Street: PACIFIC\_ST Cross Street: DARWIN\_AVE Location: SW

ADA ID: RPRK211005182106 Ramp Type: Type 1 - Perpendicular Diagonal Initial Pass/Fail: Fail Overall Compliance: No Severity Score: 32

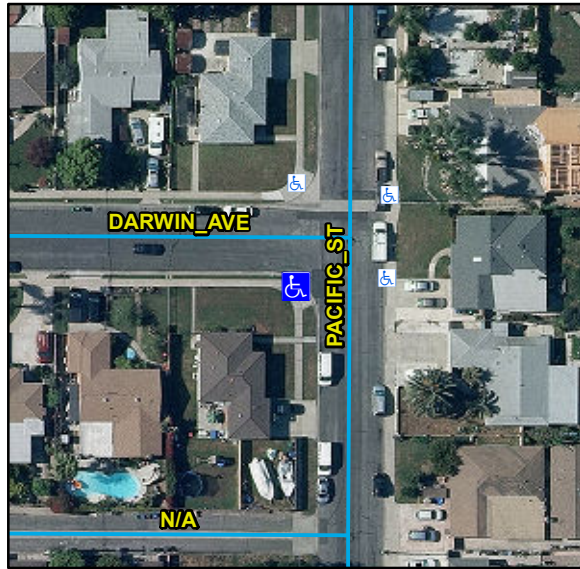
| Compliance | Description | Data | Compliance | Description | Data |
|---|---|---|---|---|---|
| No | Ramp Run Slope (%) | 14.4 | N/A | Flare Slope LT (%) | N/A |
| No | Ramp Cross Slope (%) | 3.4 | N/A | Flare Traversable LT | N/A |

**Remove & Replace Curb Ramp With Two New Directional Ramps or Equivalent.**

**R304.2.2, R304.5.3, STD 1115**
