Access Compliance Report Public Rights-of-Way (Curb Ramps)

Main Street: **DARWIN_AVE** Cross Street: **PACIFIC_ST** Location: **NW**

ADA ID: **RPRK211005182232** Ramp Type: **Type 1 - Perpendicular Diagonal Initial Pass/Fail: Fail** Overall Compliance: **No** Severity Score: **16**

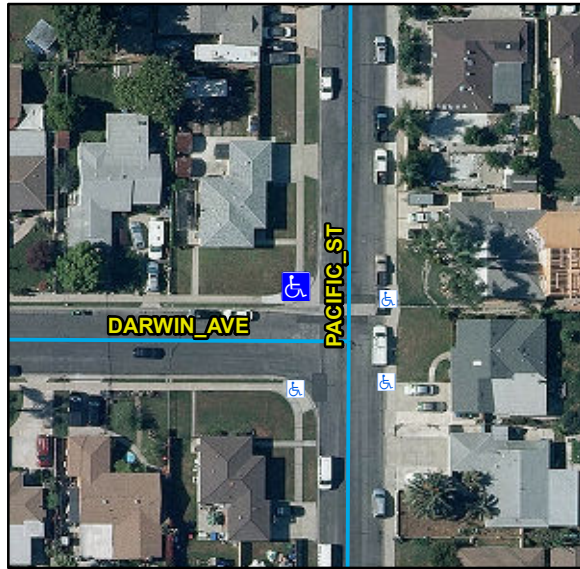
Compliance	Description	Data	Compliance	Description	Data
N/A	Ramp Length (in)	100	N/A	Flare Type LT	
Yes	Ramp Width (in)	48			N/A
No	Ramp Run Slope (%)	10.1	N/A	Flare Slope LT (%)	N/A
No	Ramp Cross Slope (%)	2.5	N/A	Flare Traversable LT	N/A
N/A	Landing Present	N/A	N/A	Flare Type RT	
N/A	Landing Length (in)	N/A			N/A
N/A	Landing Width (in)	N/A	N/A	Flare Slope RT (%)	N/A
N/A	Landing Run Slope (%)	N/A	N/A	Flare Traversable RT	N/A
N/A	Landing Cross Slope (%)	N/A	N/A	DWS Provided	N/A
N/A	Landing Movement Obstructed?	N/A	N/A	DWS Contrast	N/A
	Landing Movement Type	N/A	N/A	DWS Length (in)	N/A
N/A	Landing Shared	N/A	N/A	DWS Full Width	N/A
N/A	Clear Space	Yes	N/A	DWS Offset Left (in)	N/A
N/A	Clear Space To Crosswalk (in)	N/A	N/A	DWS Offset Right (in)	N/A
N/A	Marked Crosswalk 1	No	N/A	Marked Crosswalk 2	No
	Crossing 1 Direction	S		Crossing 2 Direction	E
	Marked Crosswalk 1 Width (in)	N/A		Marked Crosswalk 2 Width (in)	N/A

N/A	Ramp Inside Crosswalk 1	N/A	Yes	Ramp Inside Crosswalk 2	N/A
	Crossing 1 Slope (%)	10.5		Crossing 2 Slope (%)	1.4
	Crossing 1 Cross Slope (%)	1.5		Crossing 2 Cross Slope (%)	0.9
N/A	Gutter Ponding	N/A	No	Curb Slope	14.9
Yes	Gutter Lip Height (in)	0		Road Run Slope (%)	0.9
N/A	Gutter Run Slope (%)	N/A		Road Cross Slope (%)	3.1
N/A	Gutter Cross Slope (%)	N/A			
Yes	Overall Surface Condition: Acceptable		Yes	Perp Joint Present	Yes
	Cross Gutter Present?	Yes		Spandrel Present?	Yes
	Replace Cross Gutter?	No		Replace Spandrel?	No

Possible Solutions:
Remove & Replace Curb Ramp With Two New Directional Ramps or Equivalent.

OC Std/PROW:
R304.2.2, R304.5.3, STD 1115
