# Access Compliance Report Public Rights-of-Way (Curb Ramps)

Main Street: **BROWNING\_AVE** Cross Street: **IRVINE\_BLVD** Location: **SE**

ADA ID: **RPRK211006110511** Ramp Type: **Type 1 - Perpendicular Diagonal Initial Pass/Fail: Pass** Overall Compliance: **No** Severity Score: **7**

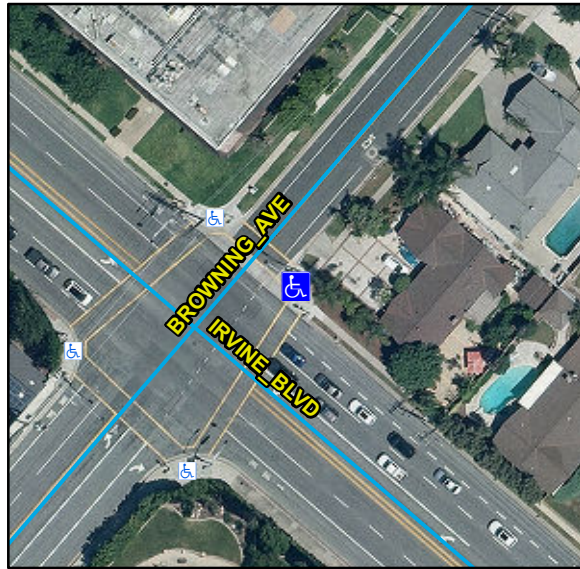
| Compliance | Description | Data | Compliance | Description | Data |
|---|---|---|---|---|---|
| <b>No</b> | Landing Run Slope (%) | <b>4.8</b> | <b>N/A</b> | Flare Traversable RT | <b>No</b> |
| <b>No</b> | Gutter Ponding | <b>Yes</b> | <b>No</b> | Curb Slope | <b>16.8</b> |
| <b>No</b> | Gutter Run Slope (%) | <b>5.4</b> | | Road Cross Slope (%) | <b>2.6</b> |

**Remove & Replace Curb Ramp With Two New Directional Ramps or Equivalent. Remove & Replace Gutter.**

**R304.2.2, R304.2.1, R304.2.2-Perp, R304.3.2-Para, R302.7, R304.5.4, STD 1115**
