# Access Compliance Report Public Rights-of-Way (Curb Ramps)

| Main Street: IRVINE_BLVD | | Cross Street: BROWNING_AVE | | Location: | S |
| ADA ID: RPRK211006112535 | Ramp Type:Type 1 - Perpendicular Diagonal Initial Pass/Fail: Fail | | Overall Compliance: No | Severity Score: | 15 |

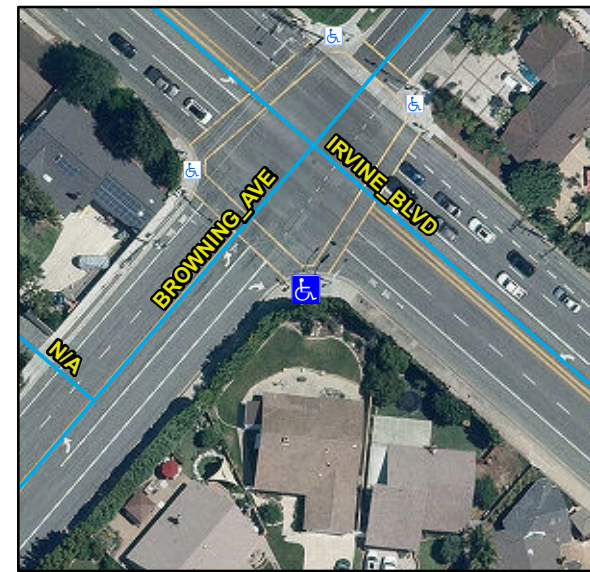
| Compliance | Description | Data | Compliance | Description | Data |
|---|---|---|---|---|---|
| No | Ramp Run Slope (%) | 11.8 | N/A | Flare Slope LT (%) | N/A |

**Remove & Replace Curb Ramp With Two New Directional Ramps or Equivalent.**

**R304.2.2, STD 1115**

Total Cost: \$ 6160
