# Access Compliance Report Public Rights-of-Way (Curb Ramps)

Main Street: IRVINE\_BLVD Cross Street: RANCHWOOD\_RD Location: NE

ADA ID: RPRK211006112956 Ramp Type: Type 1 - Perpendicular Diagonal Initial Pass/Fail: Pass Overall Compliance: No Severity Score: 15

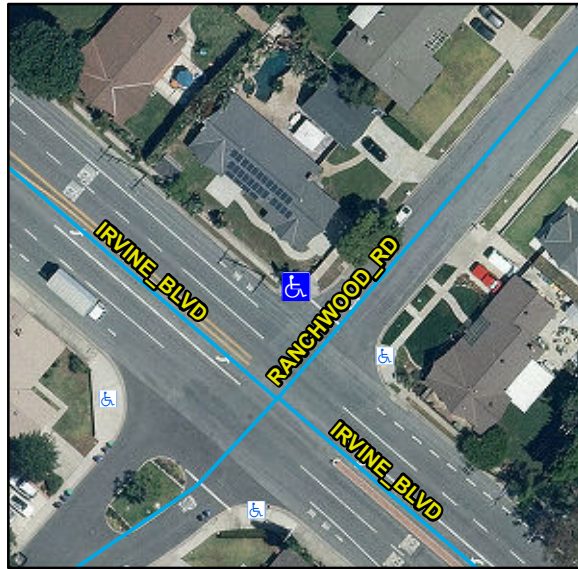
| Compliance | Description | Data | Compliance | Description | Data |
|---|---|---|---|---|---|
| No | Landing Width (in) | N/A | N/A | Flare Slope RT (%) | 11.5 |
| No | Landing Run Slope (%) | N/A | N/A | Flare Traversable RT | No |
| No | Landing Cross Slope (%) | N/A | Yes | DWS Provided | Yes |
| Yes | Gutter Ponding | No | No | Curb Slope | 10.3 |
| No | Gutter Run Slope (%) | 6.1 | | Road Cross Slope (%) | 1.1 |

Remove & Replace Curb Ramp With Two New Directional Ramps or Equivalent. Remove & Replace Gutter.
